Wetlands Research Program Technical Report WRP-RE-17

Proceedings of the National Workshop on Geotextile Tube Applications

by Jack E. Davis, Mary C. Landin

April 1997 – Final Report
Approved For Public Release; Distribution Is Unlimited

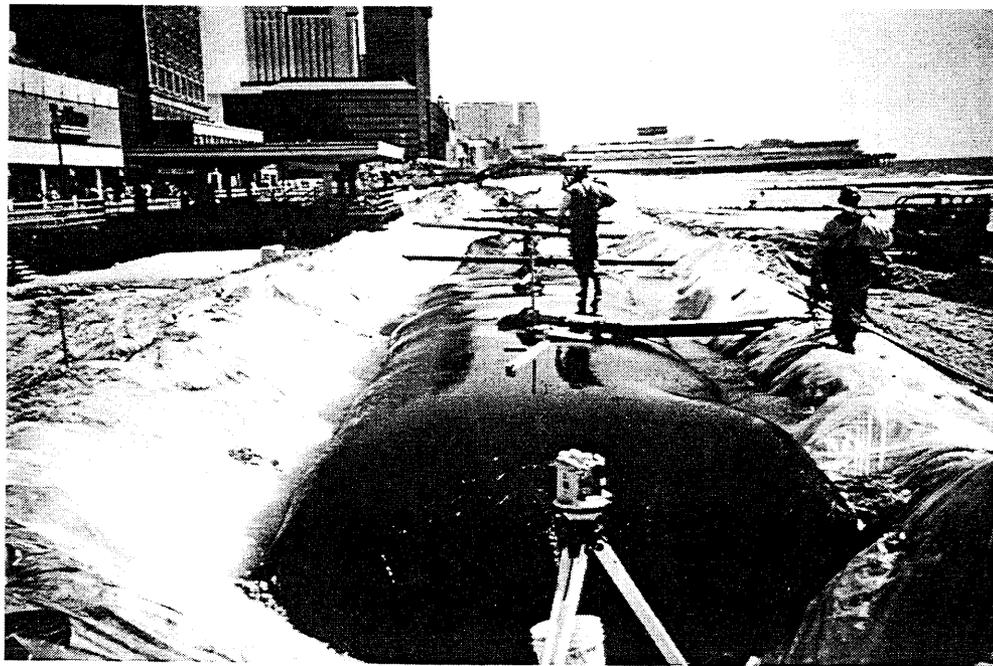
Figure 1. Construction of the geotextile tube in front of the Atlantic City, NJ, boardwalk

Atlantic City, NJ. Geotextile tubes were placed in 1995 in front of the boardwalk along Atlantic City's beach as part of a municipal shore protection project. Apparently, sand is forced beneath the boardwalk during storms, which damages the structure. A trench was excavated along the existing dune, and an impermeable barrier (such as plastic) was placed in the trench. The tube was placed in the trench on top of the impermeable fabric. An induction pump was used to dredge sand off the beach and fill the tubes. The impermeable underliner captured water permeating out of the tube and directed it to an outlet to prevent erosion around the tubes. Figure 1 shows the tube under construction. The tube was then covered over with sand and vegetated, giving the site the appearance of a natural dune. The design was unobtrusive. In the event of a storm, the tube would become exposed and act as shore protection. Hence, the tube is hidden protection, only becoming evident when erosion begins. The project weathered a recent storm in which the tubes were exposed and the boardwalk was protected.

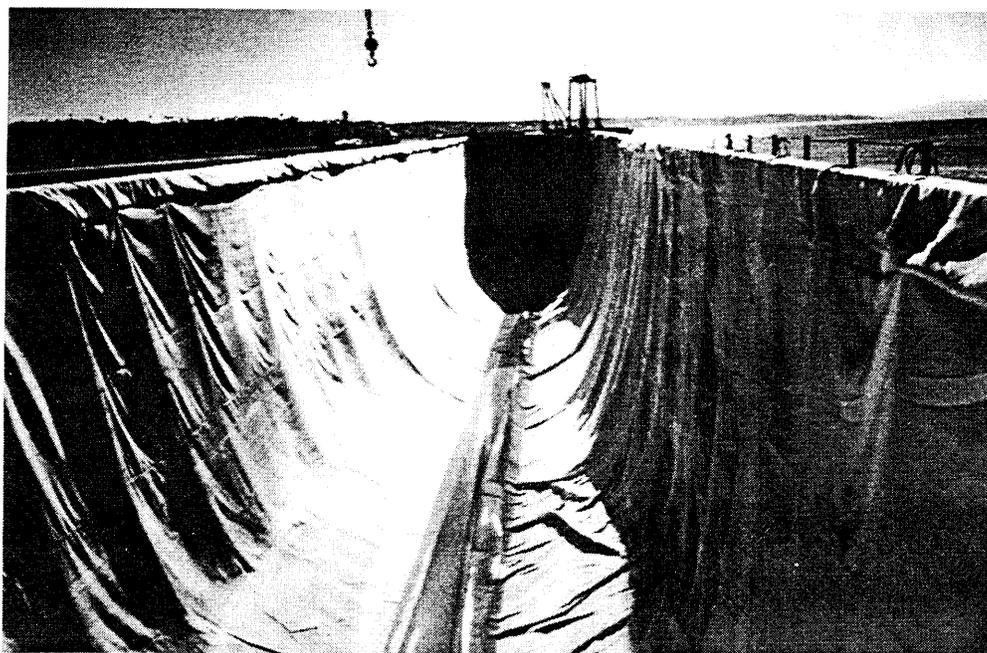
Figure 7. Geotextile liner inside a split-hull scow used in the Marina del Ray contaminated material containerization project

subsequent containers would not lodge during disposal operations. The hopper interior polypropylene woven fabric liner was permanently removed to minimize friction between the geotextile container and the bin bulkheads. It was determined that the fabric type used actually increased friction due to surface roughness. Note also that the bin was inspected to be sure it was free of burrs that might otherwise damage the geotextile fabric. The circumference of each container was increased from 90 to 120 ft to provide more sediment mobility during container release. The extra fabric was accordion folded into the bottom of the bin. The volume of material placed in each container was reduced. The optimal volume was about 1,300 cu yd. The scow was loaded differentially along its length as well, such that one end of the bin was filled 2 ft less than the other. This increased and improved the flow of water into the bin. The seam used to close the container was altered to speed up operations. Originally, a "J" seam (two layers of fabric folded over, total of four fabric layers) was used. But later, a "prayer" seam (two fabric layers) was used. This decreased the total sewing time and decreased the number of malfunctions in the sewing machine at no loss of seam strength to the container system.
